ECOLOGY AND ENVIRONMENT, INC.
REGION VI
MEMORANDUM

DATE: June 13, 1985

SUBJ: Sampling Mission to U.S. Gypsum, Corsicana, TX (TX10022)
TDD# R6-8409-09

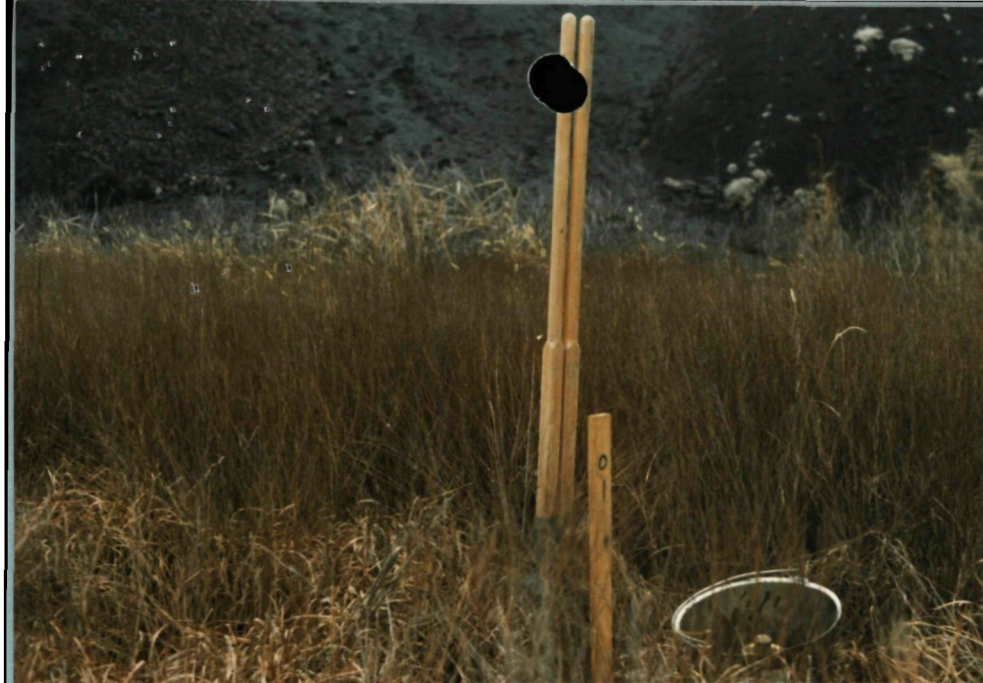
Photo # 2

Based on the analytical results of samples taken at stations 02 and 07, the waste material itself contains high levels of several metals of concern. These include antimony, arsenic, beryllium, chromium, cobalt, copper, iron, lead, manganese, nickel, tin, vanadium, and zinc. The offsite sample taken at station 03 contains elevated levels of zinc and lead. It seems unlikely that these elevated levels are a result of leachate run off from the landfill since the ground level there is approximately 5 feet higher than the base of the landfill. This sample was originally intended to be representative of the background soil concentrations for the area; however, the elevated levels of lead and zinc preclude using this for background. Due to lower metals concentrations, the sample taken at Station 01 seems to be a better example of background concentrations even though it is on site.

Comments: Sampling Station

01 on the east side
of the landfill.

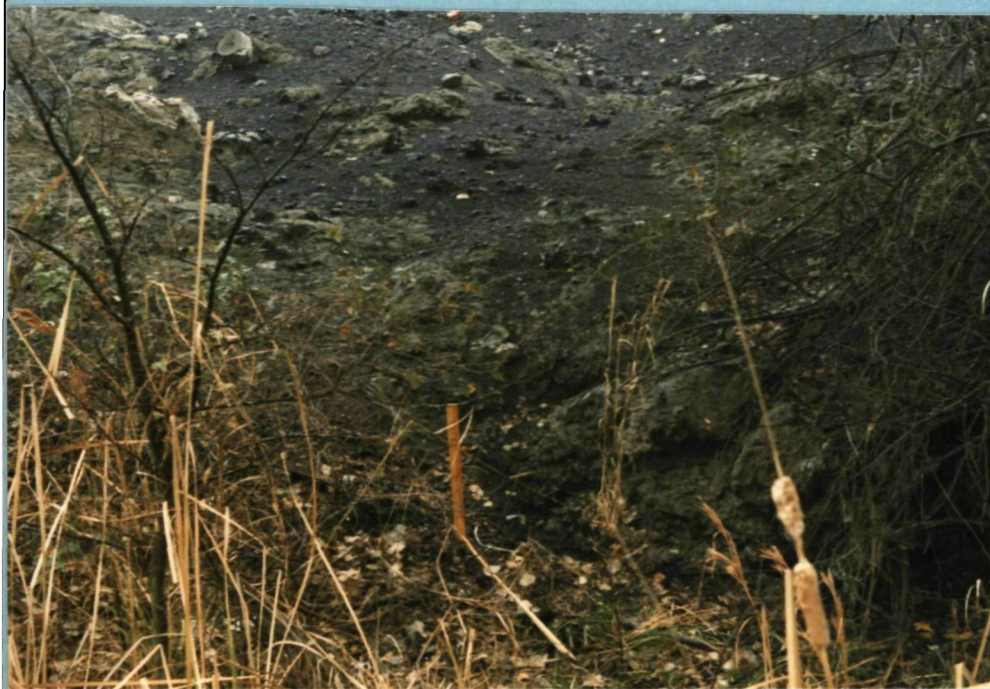
Photo # 3

Comments: Sampling Station 02

on the NW corner of the
landfill.

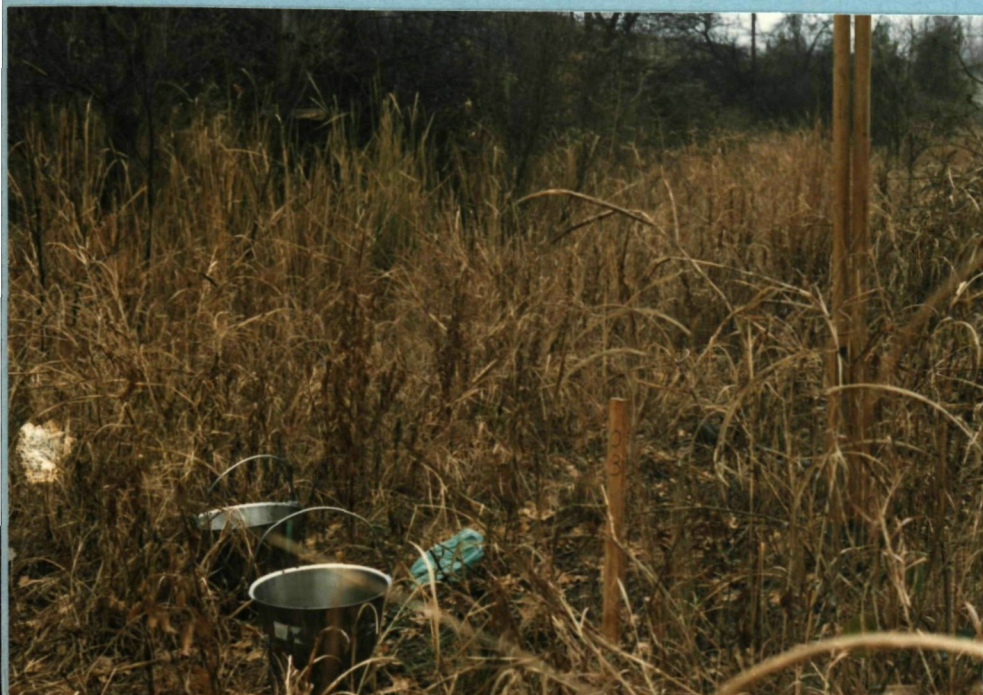
Photo # 4

It seems unlikely that the elevated zinc level in Station 03 could be a result of run off from the site since it is on higher ground. One other possibility is stack emissions from the manufacturing plant. Reliable background soil concentrations are needed to determine if contamination is present off-site from either run-off or stack emissions. Therefore, the FIT recommends further off-site sampling to make these determinations. The proposed sampling plan is included in the site sketch of the facility.

Comments: Station 03 50'

north of site at the NW
corner. (Off-site station)

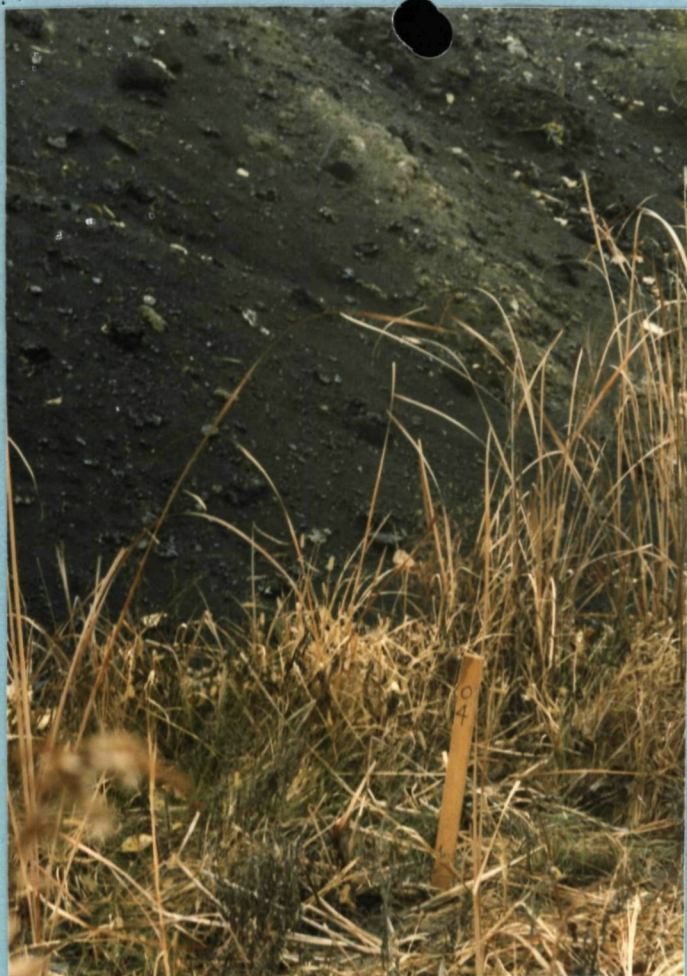
Photo #5

The drainage ditch sample at Station 04 contains elevated concentrations of arsenic, copper, lead, tin and zinc compared to ambient background levels of these elements ("Element Concentrations in Soils and Other Surface Materials of the Conterminous United States", 1984, U.S.G.S. Paper 1270). Sample 08 is from a natural drainage basin leading from the manufacturing plant and from the location of ponds that have since been drained. The levels of arsenic, lead and zinc from this sample are higher than all other samples except from the samples of the actual waste material itself. The sample taken at station 05 is off-site in a road side ditch that receives drainage from the area of Station 08. It has elevated levels of arsenic and zinc compared to ambient background levels of these elements.

Comments: Station 04 on the
west side of landfill in
drainage ditch.

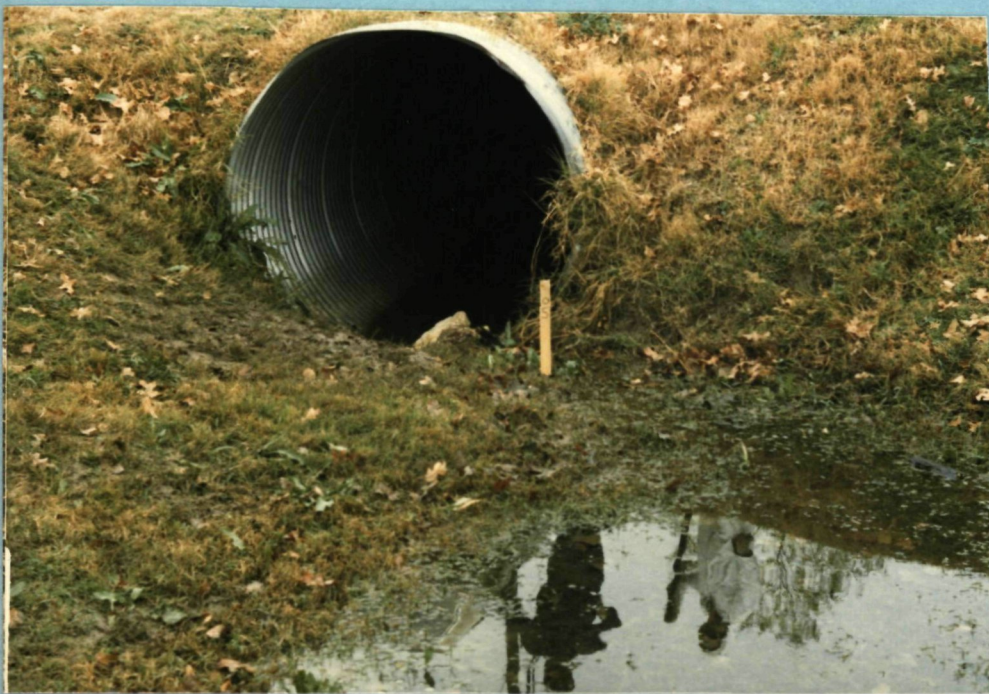
Photo #6

Comments: Station 05. Drainage
path off site 50 ft west
of property line.

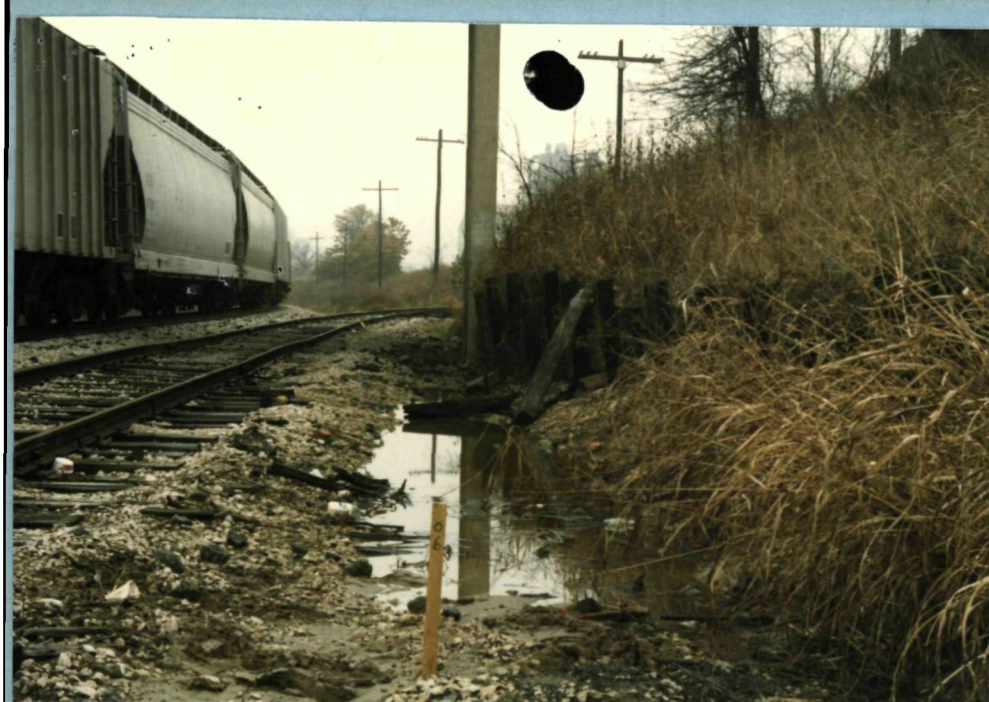
Photo # 7

Comments: Station 06 75 ft.

South of Hardy Rd on the
East side of railroad tracks.

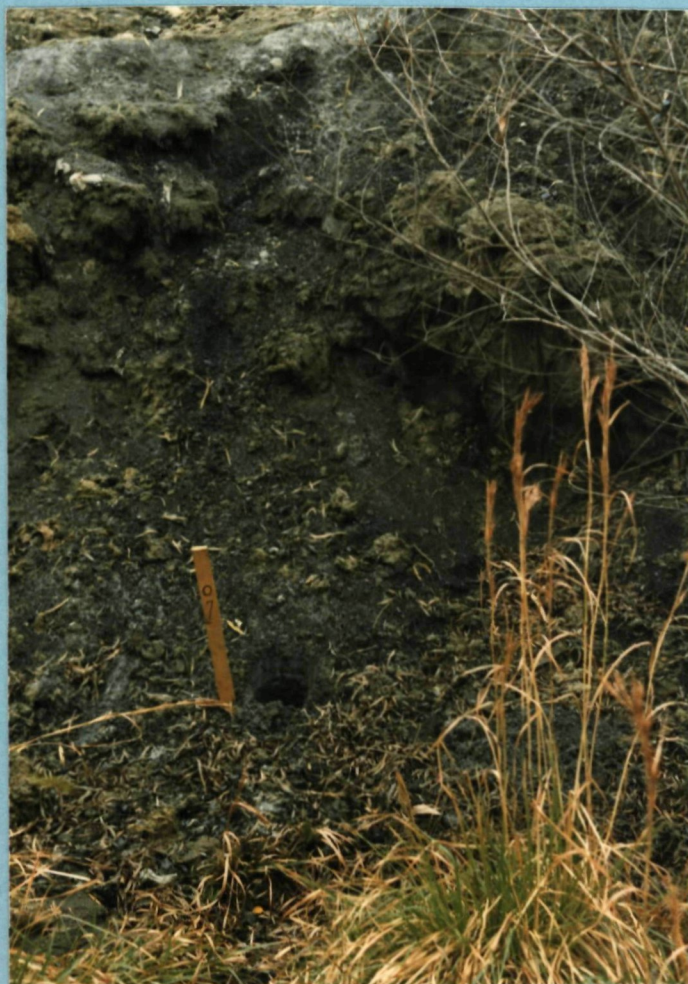
Photo # 8

Comments: Station 07 North
side of landfill.

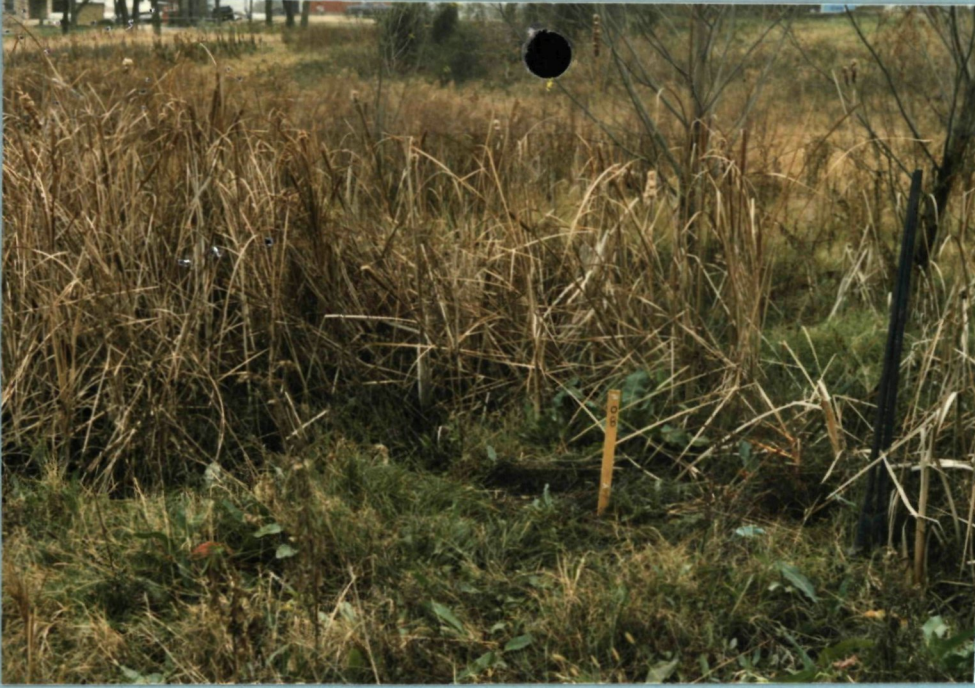
Photo # 9

Comments: Station 08. Drain-
age path approx. 1000 ft.
East of plant.
